**Flood Control Project Maintenance
Levee Inspections**

Fall 2018 Levee Maintenance Deficiency Summary Report

Sacramento River Basin

**Flood Control Project Maintenance
Levee Inspections****LMA District Cover Sheet****Fall 2018 Levee Inspection Results****Tehama County Flood Control and Water Conservation District**

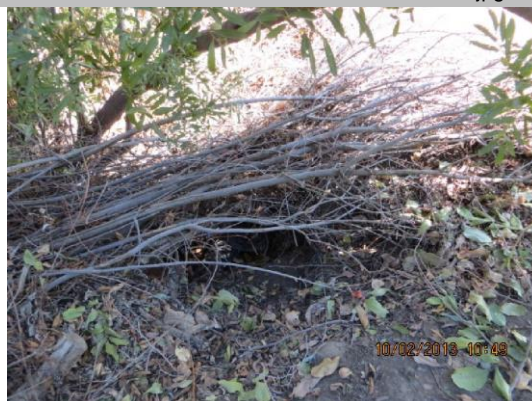
Photo 1 of 2 : UCIP_FA_2018_39840_39060.jpg

LM Start	0.17	Rating **	M	Issue No.	277
LM End	0.17	Issue Type +	En	Location *	
Category	Supplemental			GPS Latitude/Longitude	
				Start	End
Item	DWR UCIP Field Study			39.973302 °	39.973302 °
				-121.983538 °	-121.983538 °
DWR ID	24684				
Comment Code					
Inspector Comment					
FS_ID:39840 DS_ID:24684 EP_NO: N/A Repair Type: Non-Urgent Crossing Status: Found UCIP Comments: No permit identified for this crossing. FIELD_STRUCT_DESC: 36-inch reinforced concrete irrigation pipe through the levee, 0.5 feet below the crown. Concrete canal and distribution structure on the landside (LS) shoulder. FS Date: 10/2/2013

Outlet covered by tree trimmings.

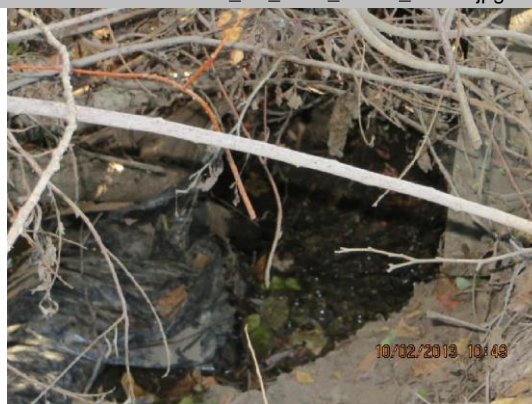
Photo 2 of 2 : UCIP_FA_2018_39840_39059.jpg

Pipe visible at WS outlet.

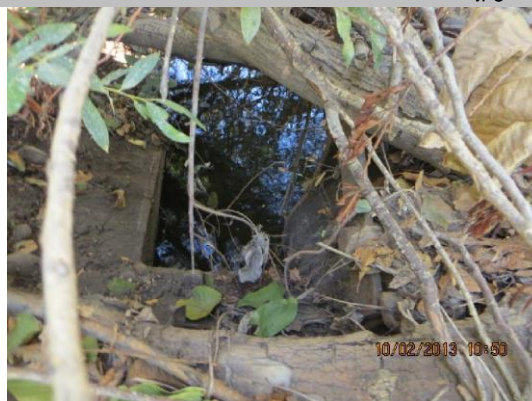
Photo 1 of 1 : UCIP_FA_2018_39838_39058.jpg

LM Start	0.17	Rating **	M	Issue No.	278	
LM End	0.17	Issue Type +	En	Location *		
Category	Supplemental			GPS Latitude/Longitude		
				Start	End	
Item	DWR UCIP Field Study			39.973285 °	39.973285 °	
				-121.983531 °	-121.983531 °	
DWR ID	24685					
Comment Code						
Inspector Comment						
FS_ID:39838 DS_ID:24685 EP_NO: N/A Repair Type: Non-Urgent Crossing Status: Found UCIP Comments: No permit identified for this crossing. FIELD_STRUCT_DESC: 24-inch reinforced concrete irrigation pipe through the levee, 2 feet below the crown. Concrete canal and distribution structure on the landside (LS) shoulder. Concrete U-shaped headwall and flap gate on the waterside (WS) toe. FS Date: 10/2/2013

Concrete U-shaped headwall and flapgate at WS toe.

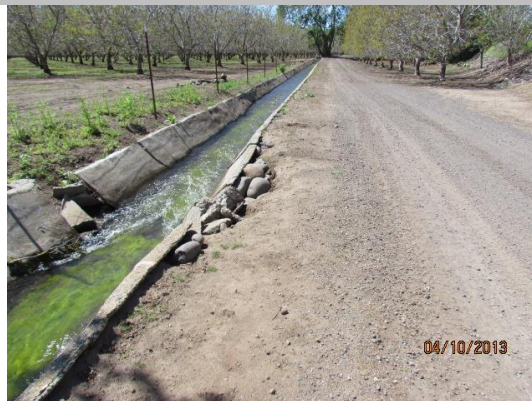
Photo 1 of 1 : FA_2018_NA0019_78_18_20180905_00006.jpg

LM Start	0.41	Rating **	M	Issue No.	18
LM End	0.41	Issue Type +	Ma	Location *	LS
Category	Earthen Levee			GPS Latitude/Longitude	
				Start	End
Item	Erosion / Bank Caving			39.972560 °	39.972560 °
				-121.987759 °	-121.987759 °
DWR ID	DWR_NA0019_01_s_2013_18				
Comment Code					
E1 : Note and monitor erosion site.					
Inspector Comment

View of the erosion along the landside slope.

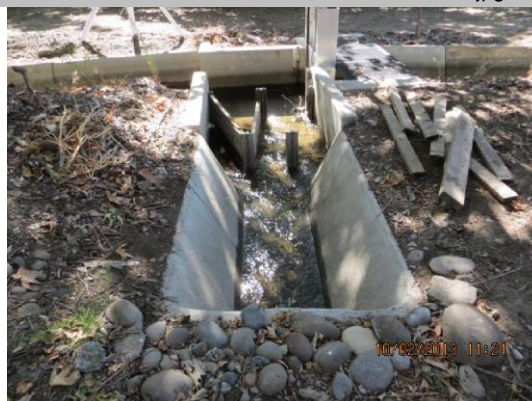
Photo 1 of 3 : UCIP_FA_2018_39839_39063.jpg

LM Start	0.49	Rating **	M	Issue No.	279
LM End	0.49	Issue Type +	En	Location *	
Category	Supplemental			GPS Latitude/Longitude	
				Start	End
Item	DWR UCIP Field Study			39.972280 °	39.972280 °
				-121.989227 °	-121.989227 °
DWR ID	24686				
Comment Code					
Inspector Comment					
FS_ID:39839 DS_ID:24686 EP_NO: N/A Repair Type: Non-Urgent Crossing Status: Found UCIP Comments: No permit identified for crossing. FIELD_STRUCT_DESC: 20-inch reinforced concrete irrigation pipe through the levee, 2 feet below the crown. Concrete canal and distribution structure with slat boards on the landside (LS) shoulder. FS Date: 10/2/2013

Concrete canal/distribution box on LS shoulder.

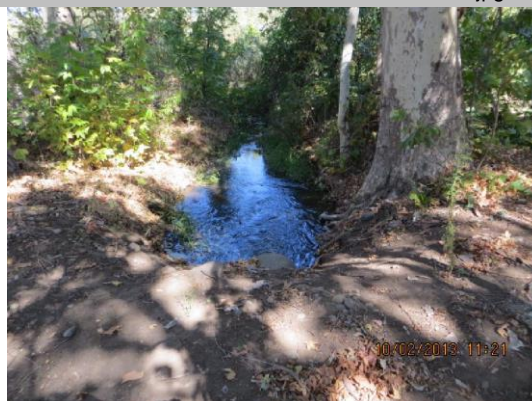
Photo 3 of 3 : UCIP_FA_2018_39839_39061.jpg

Pipe visible at outlet on WS toe.

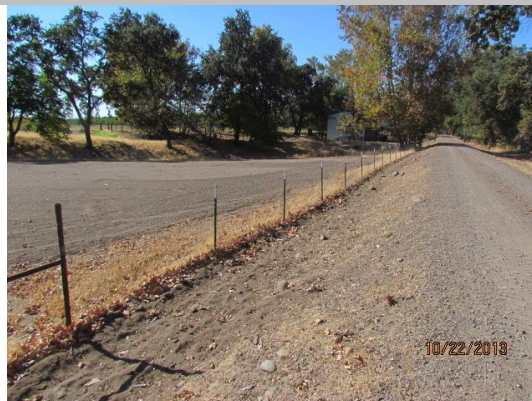
Photo 1 of 1 : FA_2018_NA0019_78_21_20180905_00009.jpg

LM Start	1.47	Rating **	M	Issue No.	21	
LM End	1.47	Issue Type +	Ma	Location *	LS	
Category	Earthen Levee			GPS Latitude/Longitude		
				Start		End
Item	Slope Stability			39.969702 °		39.969702 °
				-122.006975 °		-122.006975 °
DWR ID	DWR_NA0019_01_f_2013_21					
Comment Code						
S2 : Repair the levee slope damaged by foot traffic and prevent access where possible.						
Inspector Comment						
Keep livestock off levee and repair damage.

View of the erosion caused by livestock on both slope of the levee.

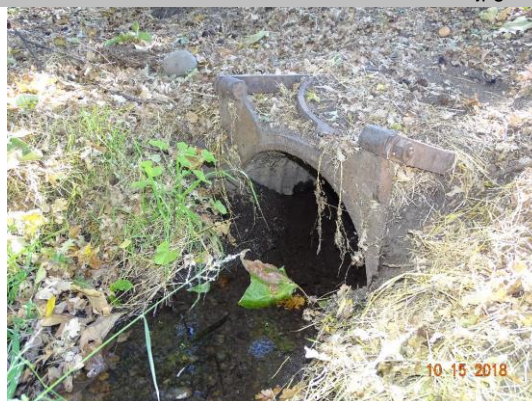
Photo 1 of 3 : UCIP_FA_2018_53391_78193.jpg

Comment Code						
Inspector Comment						
FS_ID:53391 DS_ID:20770 EP_NO: N/A Repair Type: Urgent Crossing Status: Found UCIP Comments: 10/15/2018 Flap gate on WS end stuck open. Lower part of pipe is silted that makes impossible flap gate to fully close. Needs sediment cleanup around pipe outlet on WS. (O.Yakimov - DWR)12/05/2016 Sediment buildup inside pipe (see photo) and sediment buildup on WS blocking flap gate. Crossing has been downgraded from Urgent to Non-Urgent crossing was closed on both WS and LS. (O. Magana - DWR UCIP)10/02/2013 Flapgate blocked by soil buildup. (W. Wylie - DWR UCIP) FIELD_STRUCT_DESC: 24-inch steel drainage pipe through the levee, 1.5 feet below the crown. Flap gate on the waterside (WS) toe. [Additional Reference(s): DWR Levee Log, 1992. USACE Sacramento O&M Manual Unit 509, March 1957, As-built drawings available 50-4-2394 (Station 185+40)]. FS Date: 10/15/2018 3:31:56 PM

Open flap gate on WS end. Pipe is partially silted.

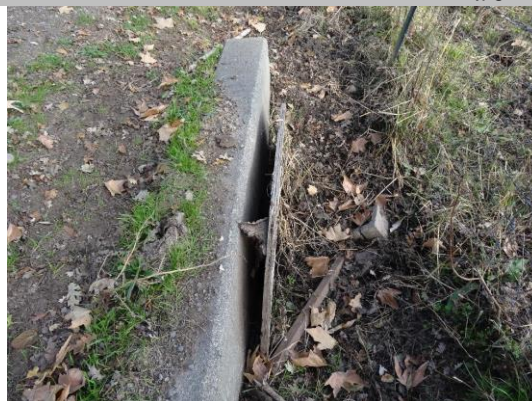
Photo 3 of 3 : UCIP_FA_2018_53391_76779.jpg

LS view of concrete headwall with wood panel blocking opening.

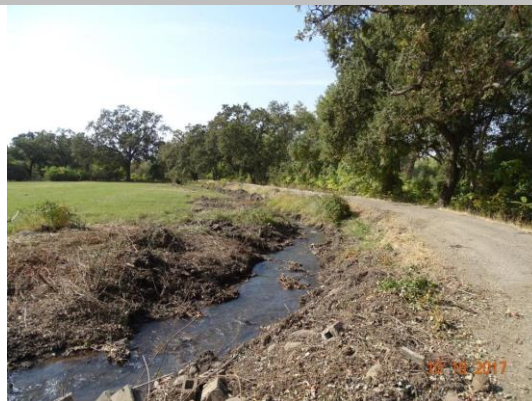
Photo 1 of 2 : FA_2018_NA0019_78_2_20180905_00001.jpg

LM Start	1.79	Rating **	U	Issue No.	2
LM End	2.22	Issue Type +	En	Location *	LS
Category	Earthen Levee			GPS Latitude/Longitude	
				Start	End
Item	Encroachments			39.969443 °	39.966921 °
				-122.012261 °	-122.019469 °
DWR ID	DWR_NA0019_01_s_2012_2				
Comment Code					
DT : Ditch					
Inspector Comment					
Repair the cleaned out irrigation ditch along the landside toe.

View of the irrigation ditch along the landside toe.

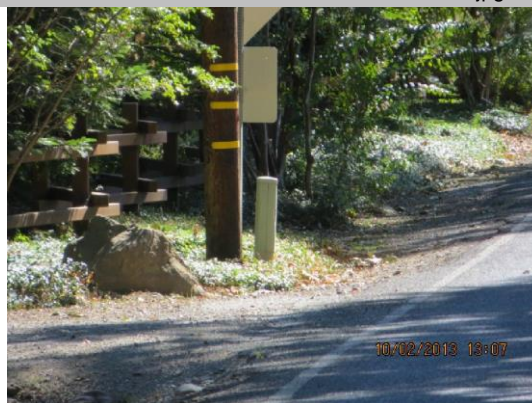
Photo 1 of 3 : UCIP_FA_2018_39837_39067.jpg

LM Start	1.88	Rating **	M	Issue No.	281	
LM End	1.88	Issue Type +	En	Location *		
Category	Supplemental			GPS Latitude/Longitude		
				Start	End	
Item	DWR UCIP Field Study			39.969156 °	39.969156 °	
				-122.013809 °	-122.013809 °	
DWR ID	24690					
Comment Code						
Inspector Comment						
FS_ID:39837 DS_ID:24690 EP_NO: N/A Repair Type: Non-Urgent Crossing Status: Found UCIP Comments: No permit identified for this crossing. FIELD_STRUCT_DESC: 4-inch steel communications conduit through the levee, at an unknown depth. Junction box off the landside (LS) toe next to JP and roadway. Conduit visible on upstream side of bridge at Deer Creek crossing. FS Date: 10/2/2013

Communication box off LS shoulder next to roadway.

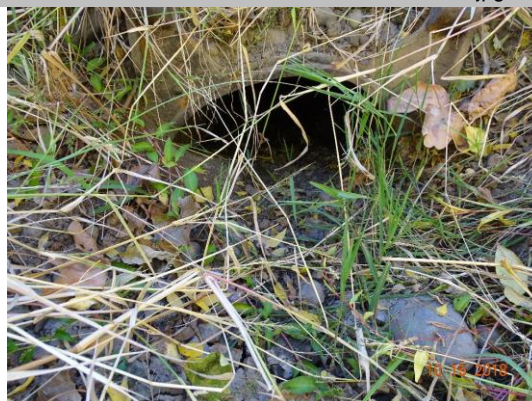
Photo 1 of 3 : UCIP_FA_2018_53392_78181.jpg

Comment Code						
Inspector Comment						
FS_ID:53392 DS_ID:20769 EP_NO: N/A Repair Type: Urgent Crossing Status: Found UCIP Comments: 10/15/2018 Flapgate on WS is missing, pipe partially blocked with silt. (O.Yakimov - DWR)12/05/2016 same as last inspection. Crossing remains "Urgent" WS opened during flood season due to damaged flap gate. (O. Magana - DWR UCIP)10/02/2013 Flapgate missing or burried on WS toe. Pipe partially blocked by soil on WS toe. (W. Wylie - DWR UCIP) FIELD_STRUCT_DESC: 24-inch corrugated metal drainage pipe through the levee, 7 feet below the crown. Flap gate located on the waterside (WS) end. A 5-foot by 5-foot concrete control structure located on the landside (LS) toe. [Additional Reference(s): DWR Levee Log, 1992. USACE Sacramento O&M Manual Unit 509, March 1957, As-built drawing no. 50-4-2394 (Station 176+10)]. FS Date: 10/15/2018 3:33:50 PM

Partially silted pipe at WS toe missing flap gate.

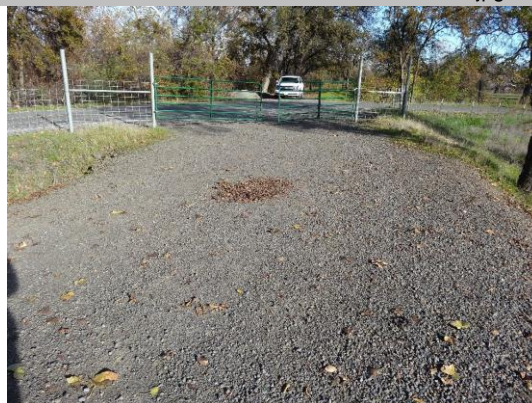
Photo 2 of 3 : UCIP_FA_2018_53392_76783.jpg

Overview of levee crown where pipe crosses.

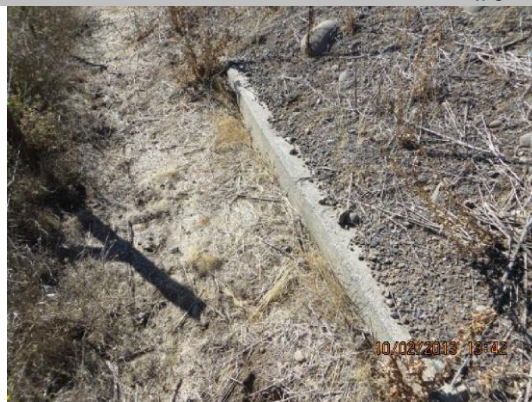
Photo 1 of 1 : UCIP_FA_2018_22823_38941.jpg

LM Start	2.57	Rating **	M	Issue No.	283	
LM End	2.57	Issue Type +	Ma	Location *		
Category	Supplemental			GPS Latitude/Longitude		
				Start	End	
Item	DWR UCIP LMA Responsibility			39.966363 °	39.966363 °	
				-122.025755 °	-122.025755 °	
DWR ID	20877					
Comment Code						
Inspector Comment						
FS_ID:22823						
DS_ID:20877						
EP_NO: N/A						
Repair Type: Non-Urgent						
Crossing Status: Found						
UCIP Comments: Headwall covered with soil. Needs to be cleared at both ends.						
FIELD_STRUCT_DESC: 24-inch corrugated metal pipe through the levee 5-feet below the crown. Calco automatic drainage gate.						
Originally included in O+M manual (1957). As-built drawings available 50-4-2394.						
FS Date: 10/2/2013

Concrete headwall on LS toe.

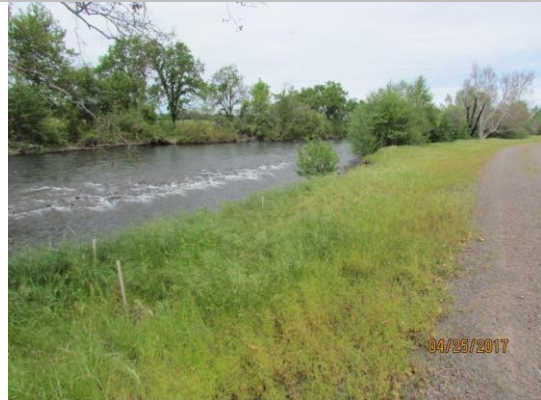
Photo 1 of 1 : FA_2018_NA0019_78_43_20180905_00017.jpg

LM Start	2.76	Rating **	A/W	Issue No.	43
LM End	2.78	Issue Type +	Ma	Location *	WS
Category	Earthen Levee			GPS Latitude/Longitude	
				Start	End
Item	Erosion / Bank Caving			39.964990 °	39.964763 °
				-122.028740 °	-122.029082 °
DWR ID	DWR_NA0019_01_s_2017_43				
Comment Code					
E2 : Schedule repair of erosion site prior to the next inspection.					
Inspector Comment					
Repair the erosion along the water side slope.

View of erosion along waterside toe.

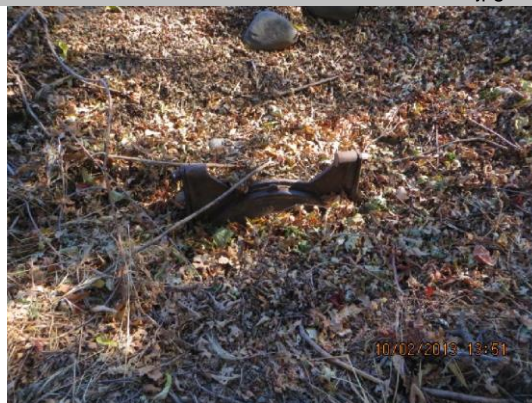
Photo 2 of 2 : UCIP_FA_2018_22824_38945.jpg

LM Start	2.86	Rating **	M	Issue No.	284	
LM End	2.86	Issue Type +	Ma	Location *		
Category	Supplemental			GPS Latitude/Longitude		
				Start	End	
Item	DWR UCIP LMA Responsibility			39.963938 °	39.963938 °	
				-122.030128 °	-122.030128 °	
DWR ID	20767					
Comment Code						
Inspector Comment						
FS_ID:22824						
DS_ID:20767						
EP_NO: N/A						
Repair Type: Non-Urgent						
Crossing Status: Found						
UCIP Comments: Pipe blocked by soil.						
FIELD_STRUCT_DESC: 24-inch corrugated metal drainage pipe through the levee, 6 feet below the crown. Flap gate on the waterside (WS) end. [Additional Reference(s): DWR Levee Log, 1992. USACE Sacramento O&M Manual 509, March 1957, (Assumed Station 137+50) Drawing No. 50-4-2394].						
FS Date: 10/2/2013

Flapgate blocked by soil and debris.

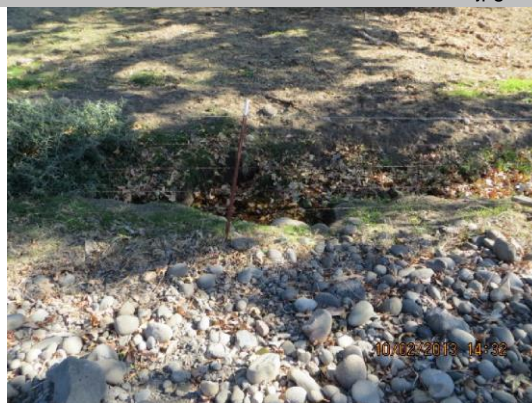
Photo 1 of 3 : UCIP_FA_2018_22825_38952.jpg

LM Start	3.29	Rating **	M	Issue No.	285	
LM End	3.29	Issue Type +	En	Location *		
Category	Supplemental			GPS Latitude/Longitude		
				Start	End	
Item	DWR UCIP Field Study			39.947484 °	39.947484 °	
				-122.049011 °	-122.049011 °	
DWR ID	20766					
Comment Code						
Inspector Comment						
FS_ID:22825						
DS_ID:20766						
EP_NO: N/A						
Repair Type: Non-Urgent						
Crossing Status: Indicator Found						
UCIP Comments: Pipe buried. Water flows to low spot and dissappears, but pipe not visible.						
FIELD_STRUCT_DESC: 24-inch pipe through the levee 8-feet below the crown, flap gate on waterward end. Originally included in O+M manual (1957). As-built drawing No. 50-4-2394.						
FS Date: 10/2/2013

Low spot with water on LS toe.

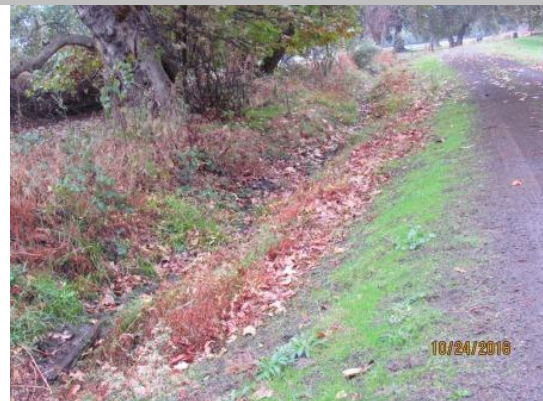
Photo 1 of 1 : FA_2018_NA0019_78_35_20180905_00011.jpg

View of the vegetation along the landside slope and toe.

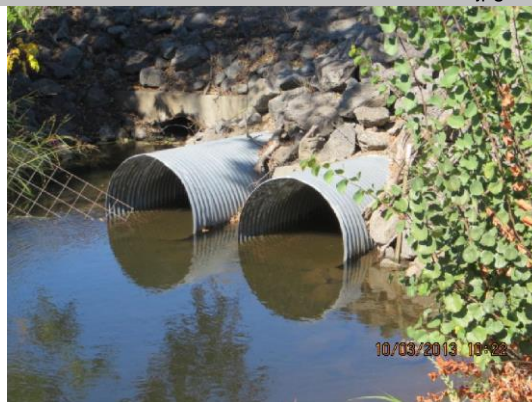
Photo 2 of 3 : UCIP_FA_2018_23007_39069.jpg

Pipe visible on LS toe.

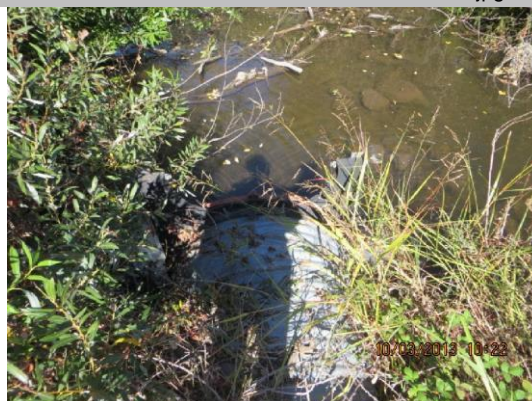
Photo 3 of 3 : UCIP_FA_2018_23007_39068.jpg

Flapgate visible on WS toe.

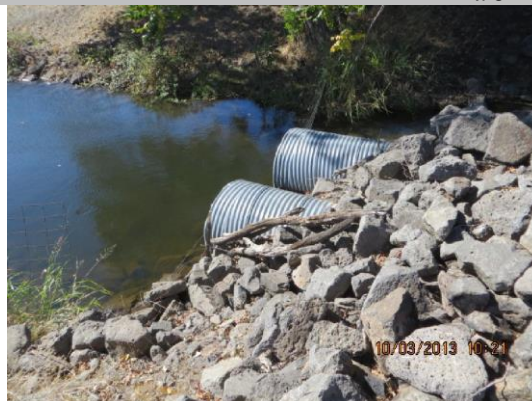
Photo 1 of 3 : UCIP_FA_2018_39836_39073.jpg

LM Start	3.60	Rating **	M	Issue No.	287	
LM End	3.60	Issue Type +	En	Location *		
Category	Supplemental			GPS Latitude/Longitude		
				Start	End	
Item	DWR UCIP Field Study			39.945952 °	39.945952 °	
				-122.054259 °	-122.054259 °	
DWR ID	24688					
Comment Code						
Inspector Comment						
FS_ID:39836						
DS_ID:24688						
EP_NO: N/A						
Repair Type: Non-Urgent						
Crossing Status: Found						
UCIP Comments: No permit identified for this crossing. Brush should be removed from flapgate outlet.						
FIELD_STRUCT_DESC: 48-inch corrugated metal drainage pipe through the levee, 6 feet below the crown. Flap gate on the waterside (WS) end.						
FS Date: 10/3/2013

Pipe visible on LS toe.

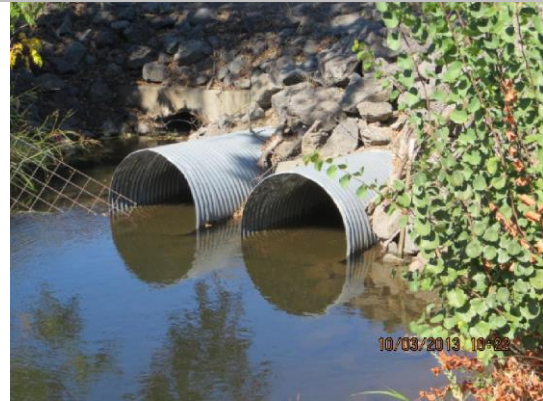
Photo 2 of 3 : UCIP_FA_2018_39836_39072.jpg

Pipe visible on LS toe.

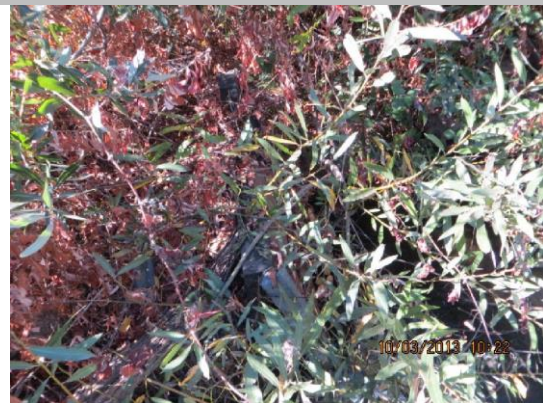
Photo 3 of 3 : UCIP_FA_2018_39836_39071.jpg

Flapgate visible on WS toe covered in brush.

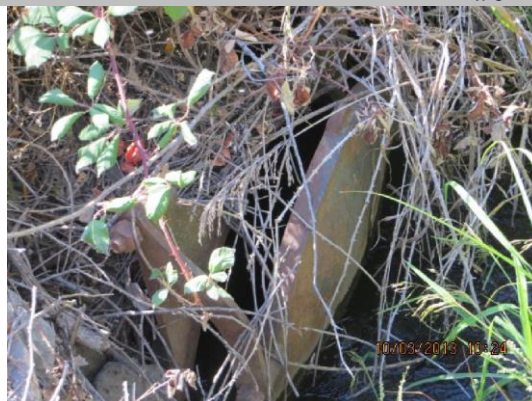
Photo 2 of 3 : UCIP_FA_2018_53393_39074.jpg

Flapgate visible on WS toe.

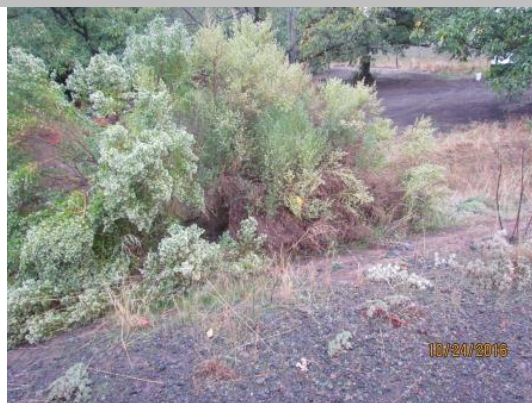
Photo 1 of 1 : FA_2018_NA0019_78_16_20180905_00004.jpg

View of a bush obstructing visibility.

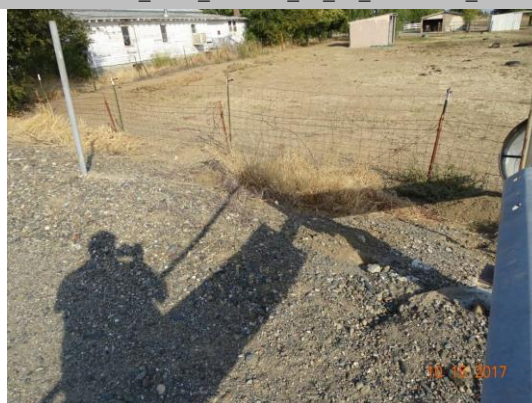
Photo 1 of 1 : FA_2018_NA0019_81_51_20180905_00023.jpg

View of the rodent holes along the landside slope.

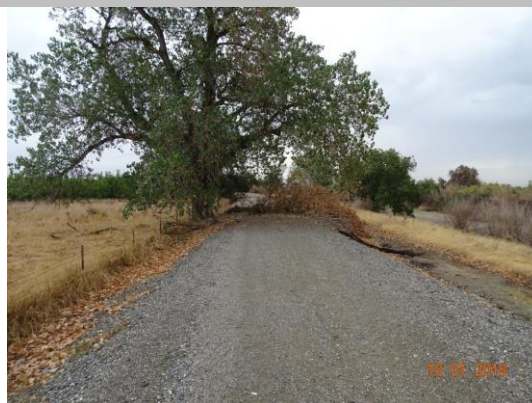
Photo 1 of 1 : FA_2018_NA0019_81_48_20181008_00079.jpg

View of the tree limb that is fallen on the crown roadway.

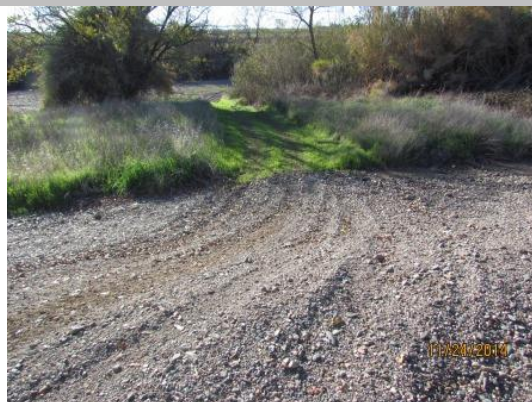
Photo 1 of 1 : FA_2018_NA0019_81_16_20180905_00011.jpg

View of the slope instability caused by vehicles along the waterside slope.

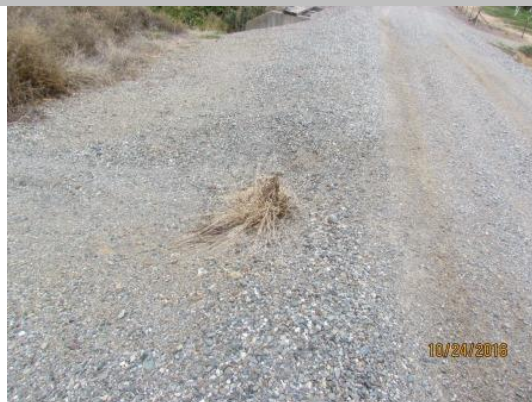
Photo 1 of 2 : FA_2018_NA0019_81_3_20180905_00003.jpg

View of a dip along the levee slope.

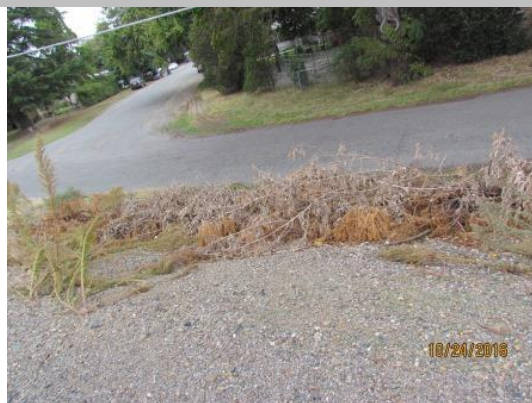
Photo 1 of 1 : FA_2018_NA0019_81_31_20180905_00018.jpg

View of the prunings along the landside toe.

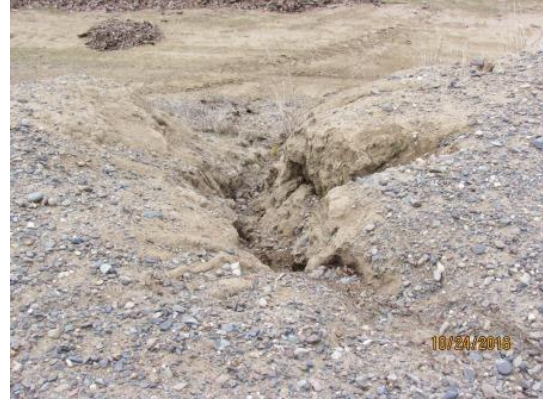
Photo 1 of 1 : FA_2018_NA0019_82_18_20180905_00007.jpg

View of the erosion along the landside slope.
